28 April 2016

QB478-01/NM/JL

COAL MINING RISK ASSESSMENT REPORT
For
Land at Timmis Road, Lye

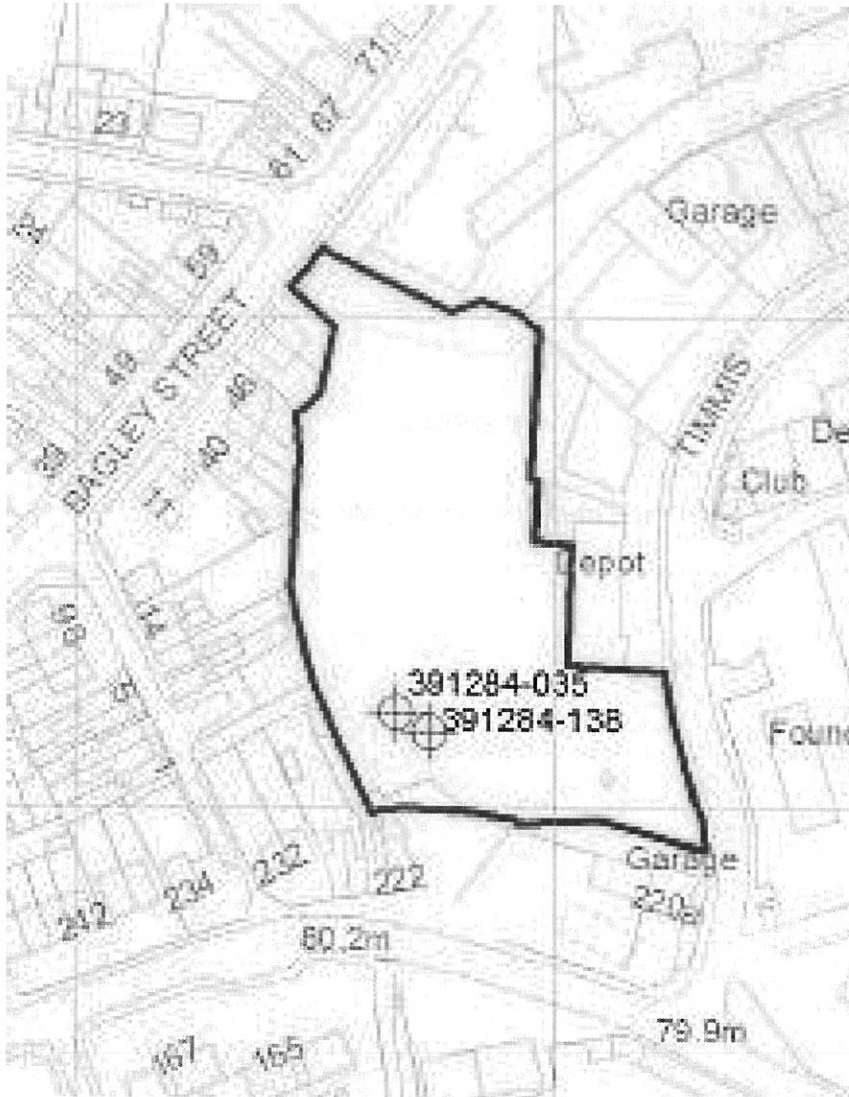
PROJECT TITLE				
DRAWING TITLE				
RUSKIN PROPERTIES		LAND OFF TIMMIS ROAD, LYE		
APPROXIMATE MINESHAFT LOCATIONS				
DRAWN BY	APPROVED BY	DATE	SCALE	DRAWING No.
JC	NM	APRIL 2016	NTS	QB478/03

- 4.2.1 The Coal Authority report, together with research of JPB archives, indicates two recorded mine entries within the site; research has not revealed specific records to

show whether the shafts have been treated. The 'best plot' position of each of the recorded mineshafts is shown on JPB Drawing QB478/03.

- 4.2.4 Apart from the rare occasion when a shaft is visible at the surface as exposed brickwork or as ground subsidence, it is the inspection of old mine plans and early Ordnance Surveys that indicate its presence. As set out in Paragraph 4.2.2 above, this causes a problem in determining the precise position of a recorded shaft. Therefore, on this site, and given the vintage of the map (1885) it is our view that the mineshaft may be up to 5m from its indicated position, as shown on JPB Drawing No. QB478/03.

- 5.2.2 It is recommended that prior to development the shafts be investigated by probe drilling and, if found, stabilised by drilling and grouting to full depth. A development standoff should also be considered from the located positions.

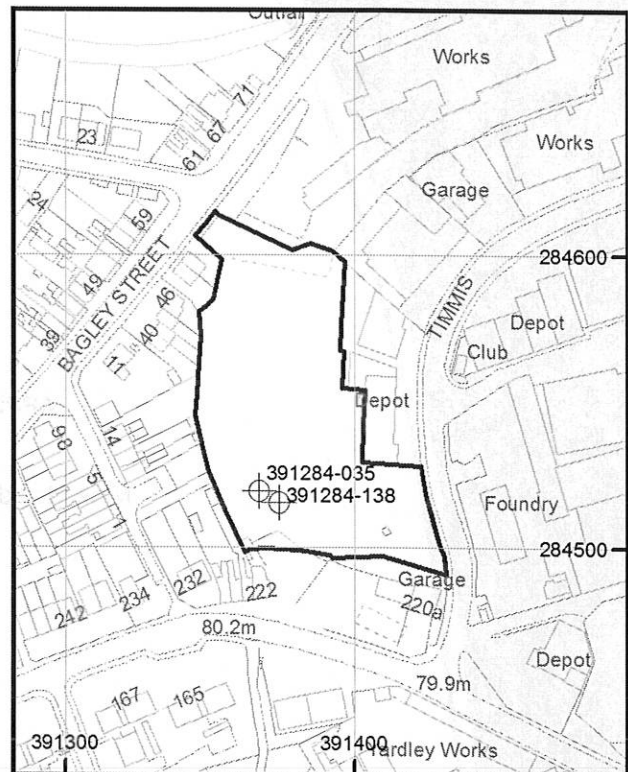
Within, or within 20 metres of, the boundary of the property there are 2 mine entries, the approximate positions of which are shown on the enquiry boundary plot.

There is no record of what steps, if any, have been taken to treat the mine entries.

In view of the mining circumstances a prudent developer would seek appropriate technical advice before any works are undertaken.

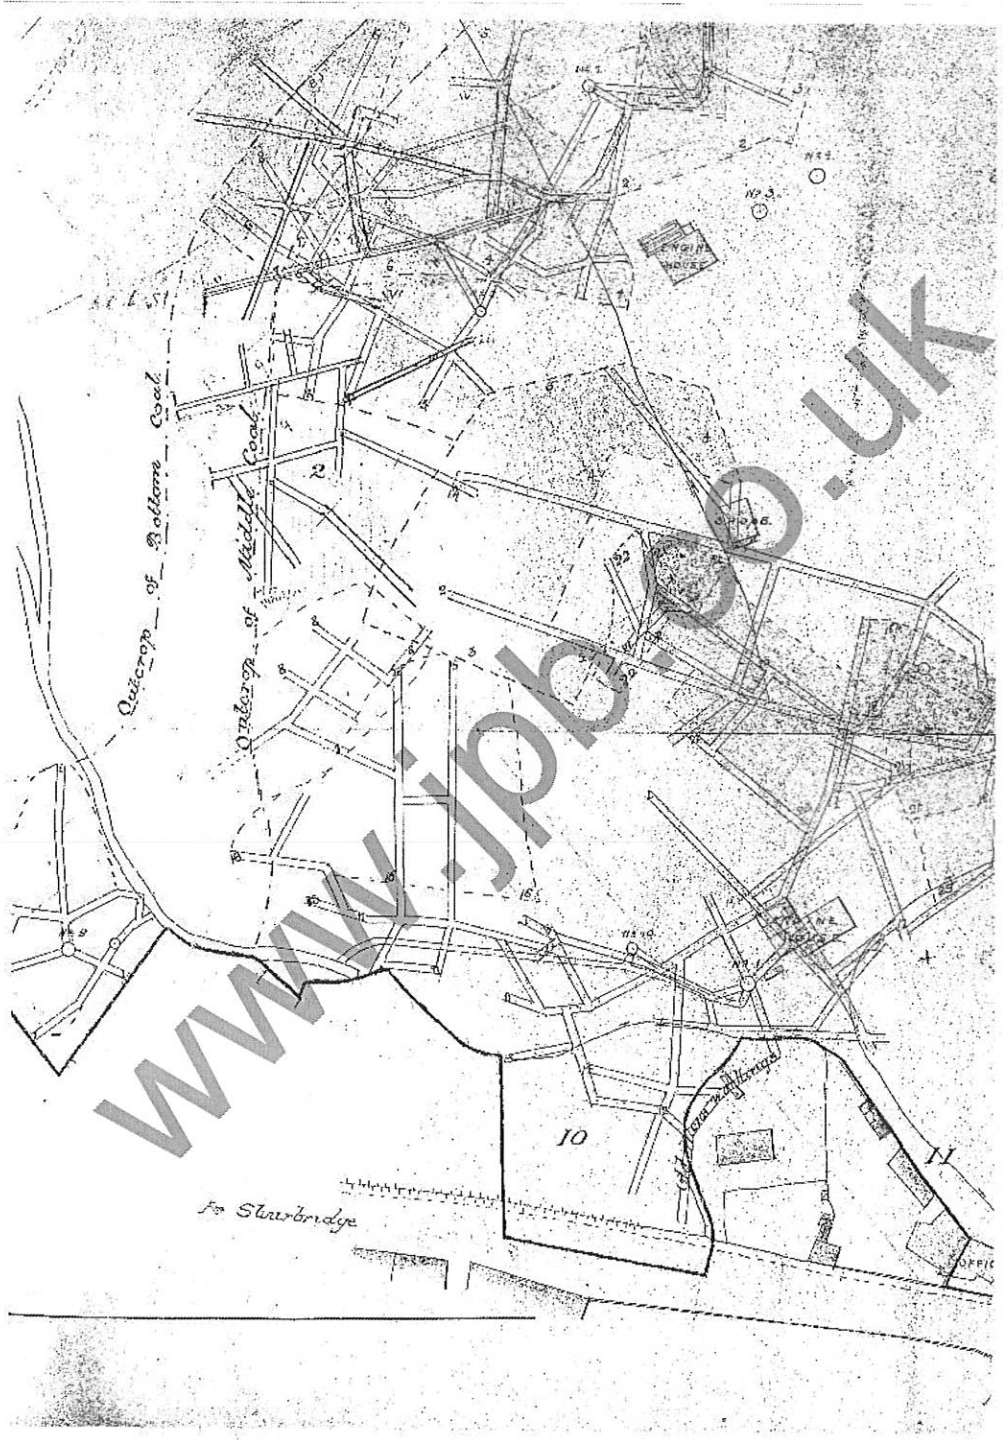
Mine Plan dated from 1803

4.1.2 JPB mine plan information shows workings from the Hill Field Colliery in an unnamed coal seam and the New Mine Fireclay seam to have extended beneath the area of the site, with a last known working date of 1919. Although only a limited number of plans have been traced, it is realistic to assume that most, if not all, of the named mineral seams from the Middle Thick Coal down through the stratigraphical sequence could have been worked in the area directly beneath and surrounding the site at some time in the past. In addition, assessing the site as a whole, the Middle Thick, Lower Thick, Upper Heathen Coal, Four Foot Earth Clay and the Lower Heathen Coal seams are all recorded as shallow seams and are within what is termed 'effective depth' of the surface at various locations across the site. Consequently should open workings remain in any of these mineral seams beneath this property, then residual settlement of these mine

workings could possibly impact upon the surface. Any remnant workings in mineral seams from the Old Mine Fireclay seam down through the sequence are below what is considered to be 'effective depth' of the surface.

5.1.1 Overall, in consideration of the prevailing near surface geology and topography of the site and the mining records and due to the age and depth of the recorded workings; it is considered that mining is **significant** to the site or the future re-development of the site. On this basis **it is recommended that investigative drilling is undertaken** to assess the shallow subsurface ground conditions and design remediation works as appropriate. In certain locations on site this may take the form of drilling and grouting and/or foundation solutions but this assessment can only be made post the recommended ground investigations
