## 6. Archaeology and Cultural Heritage

6.1.1 Pegasus Group has produced a heritage appraisal on behalf of Gallagher Estates, which provides a high-level assessment of potential heritage issues which could constrain the development at Home Farm, Sandhills.

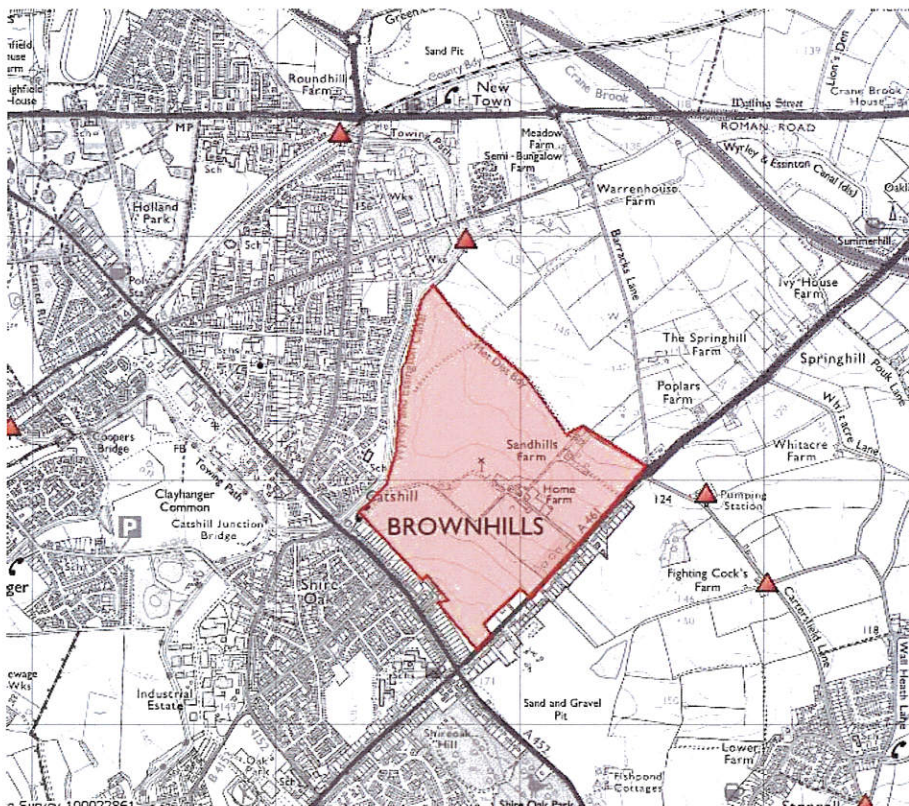
6.1.3 Within a 1km search area from the site boundary there are four Listed Buildings, all at grade II and one Scheduled Monument. These are shown on **Figure 6.1** below.

Figure 6.1 Location of listed buildings (scheduled monument located to the south)

- The Wyrley and Essington Canal Anglesey Branch Railway Aqueduct – 1077180 – 0.7km north-northwest of the site boundary;
- Wyrley and Essington Canal Footbridge at Ogley Junction – 1087076 – 0.2km north of the site boundary;
- Sandhills Pumping Station – 1421472 – 0.25km east of site boundary; and
- Fighting Cocks Farmhouse – 1374262 – 0.6km southeast of the site boundary.

6.1.5 The Scheduled Monument is Hillfort known as The Castle Fort at Castlebank Plantation (1017244) located 1km south of the site boundary. The majority of this asset is located beyond the 1km boundary, extending south towards Castlehill Road.
